# **The Road Inventory of Lake Ilo National Wildlife Refuge Dunn Center, ND**

Prepared By:  
Federal Highway Administration  
Central Federal Lands Highway Division  
July 08

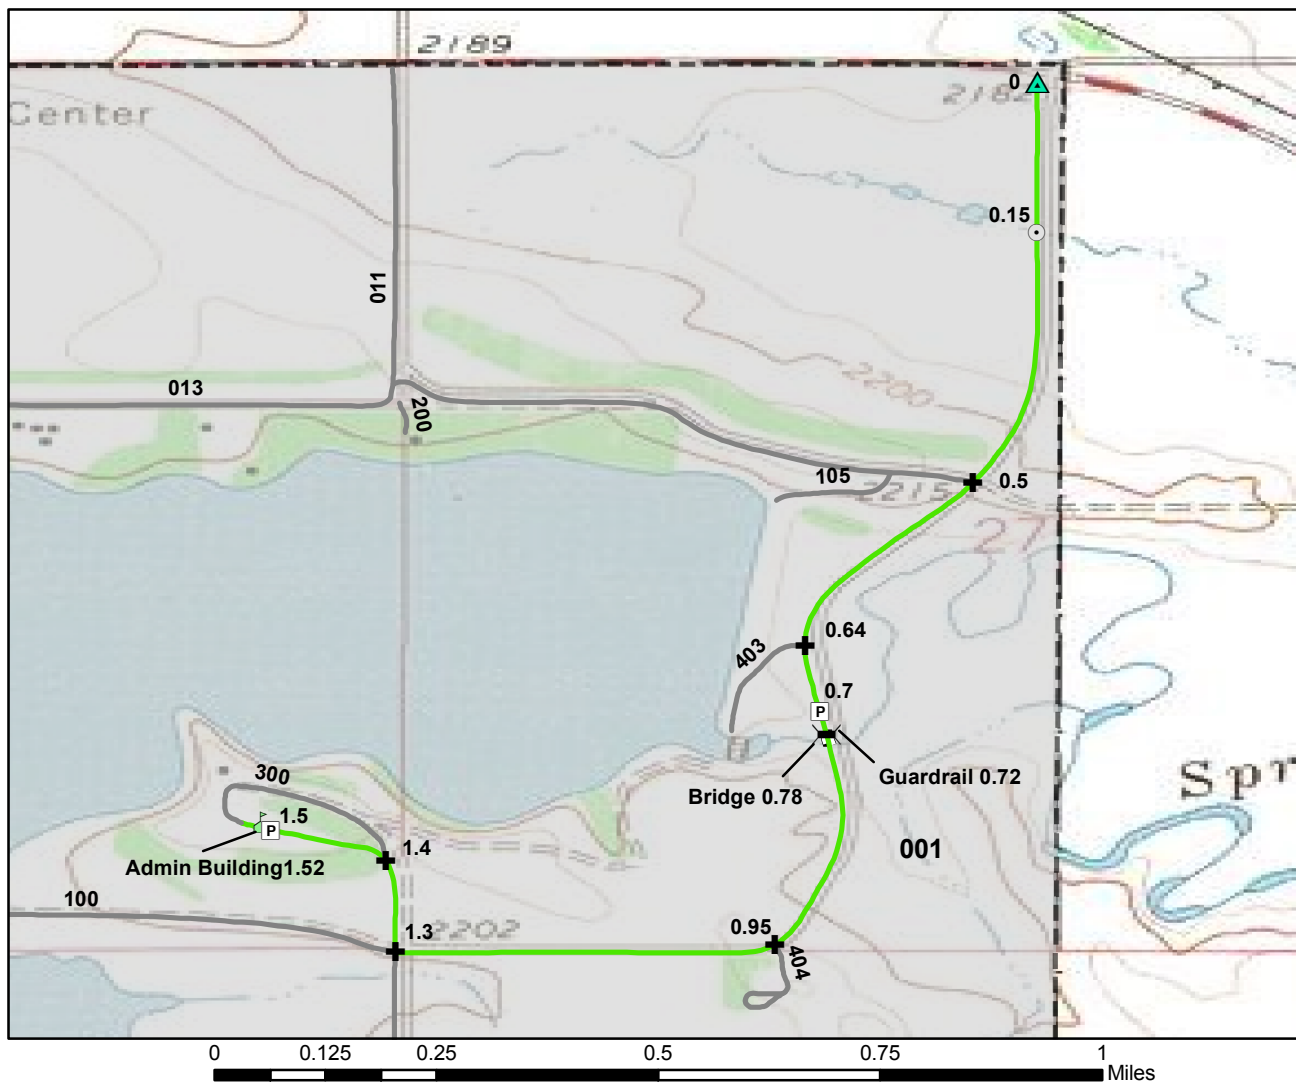
ROUTE: 010 Refuge Entrance Road

Section Number	001				
Section Length (miles)	1.56				
Inspection Date	7/7/2008				
<b>Section Information</b>					
Surface Type	Gravel				
Number of Lanes	1				
Roadway Width (feet)	14				
<b>Roadway Condition Information</b>					
Condition	Good				
Remaining Service Life (years)	7				
Cost Estimate	\$2400				
CRV	\$1024700

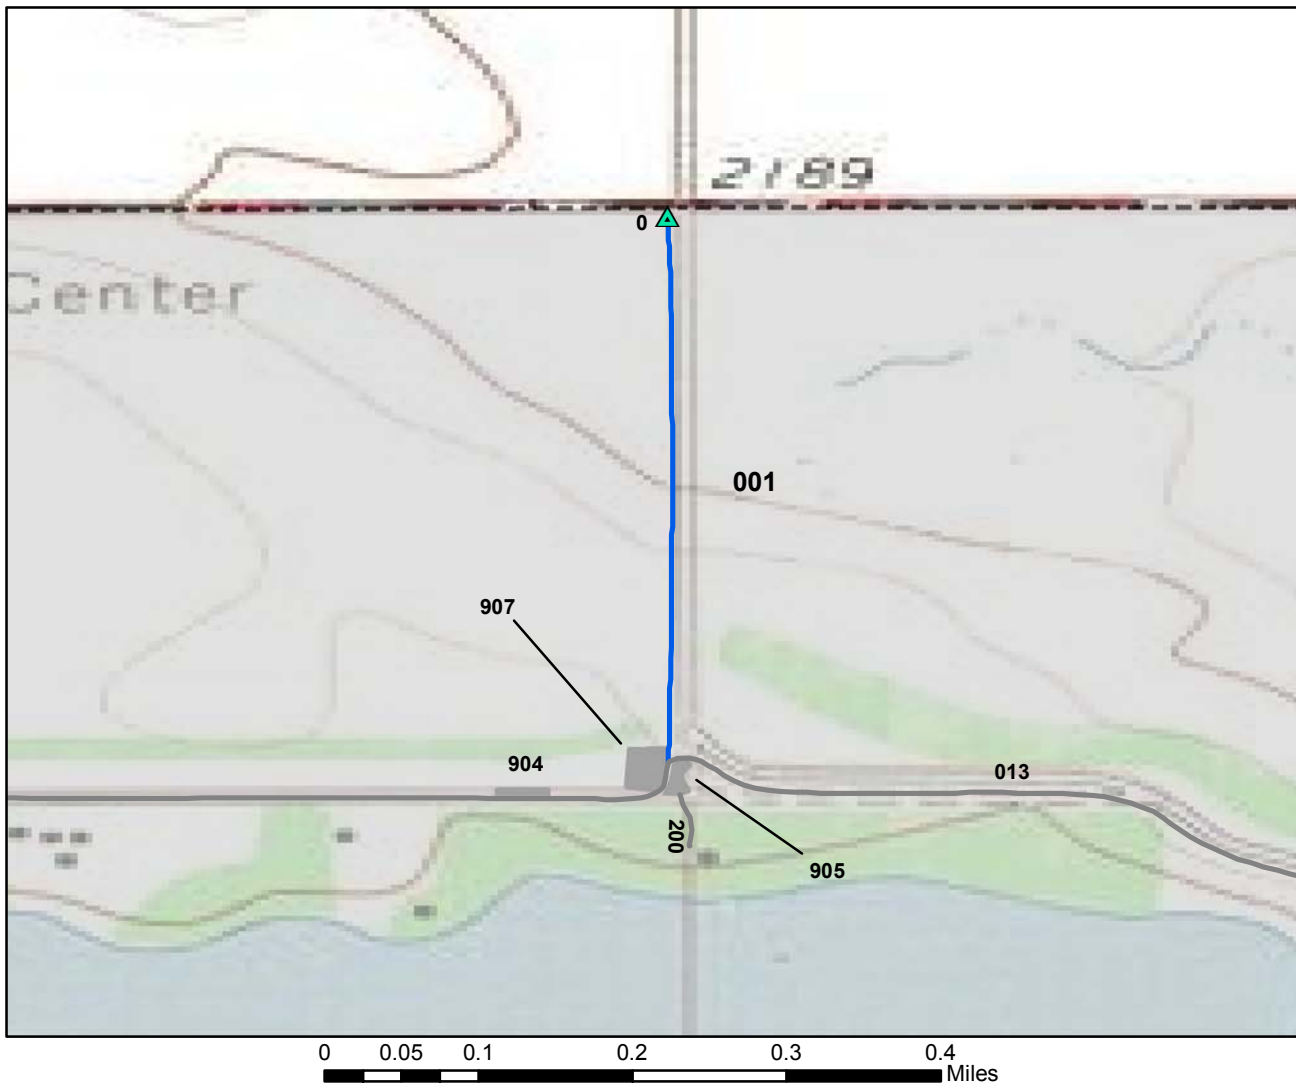
ROUTE: 011 Park Access Road TOTAL LENGTH: 0.36 Miles

Section Number	001				
Section Length (miles)	0.36				
Inspection Date	7/7/2008				
<b>Section Information</b>					
Surface Type	Gravel				
Number of Lanes	1				
Roadway Width (feet)	12				
<b>Roadway Condition Information</b>					
Condition	Excellent				
Remaining Service Life (years)	10				
Cost Estimate	\$0				
CRV	\$233300

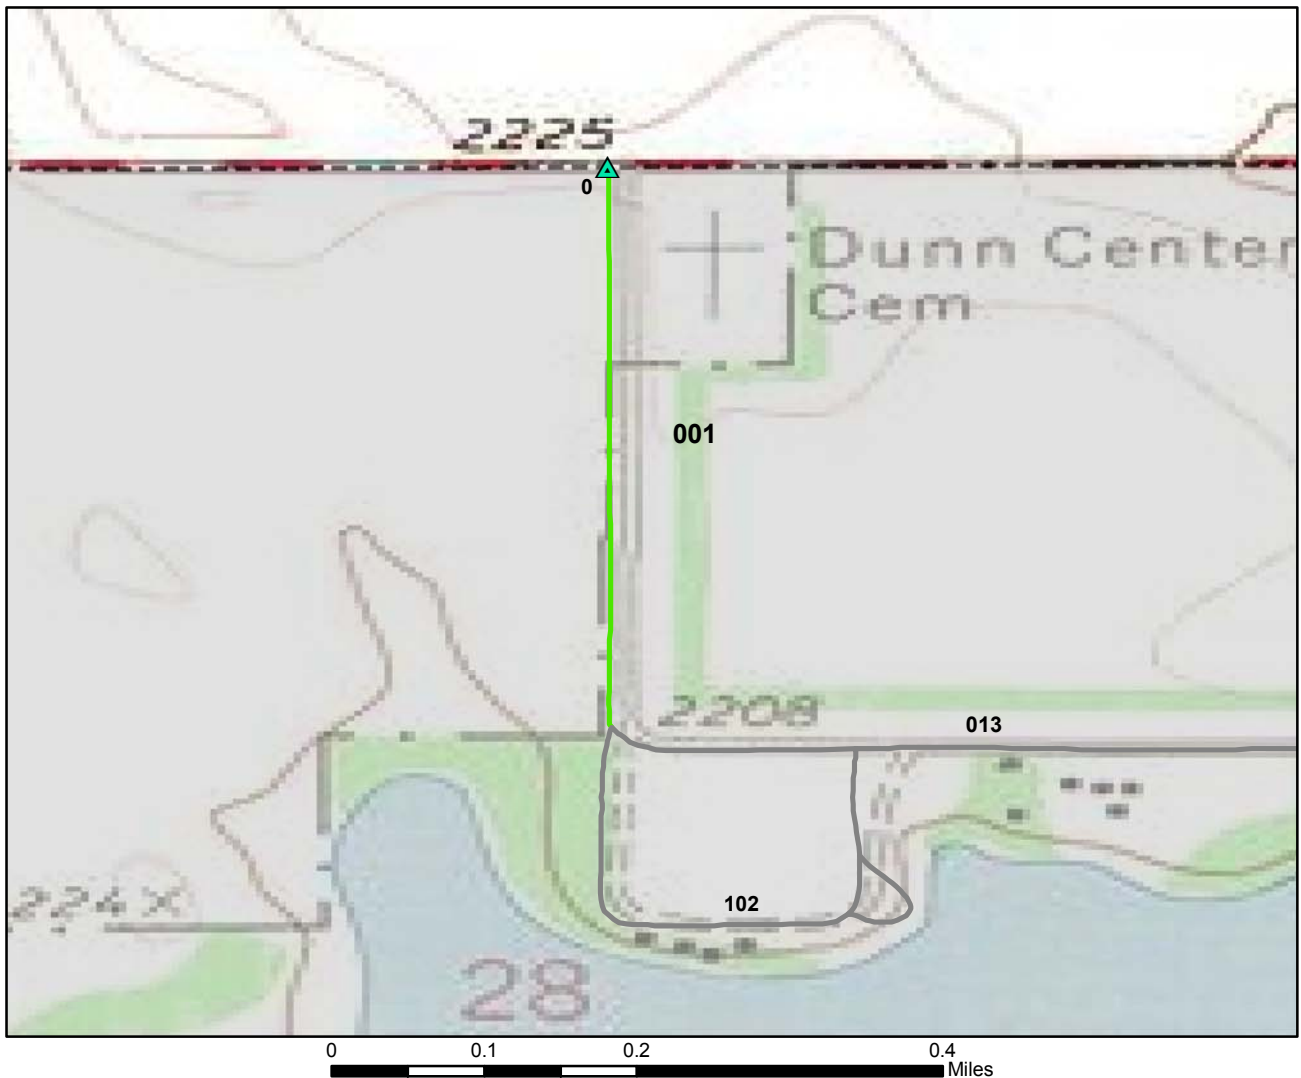
ROUTE: 012 Cemetery Lake Road

Section Number	001				
Section Length (miles)	0.37				
Inspection Date	7/7/2008				
<b>Section Information</b>					
Surface Type	Gravel				
Number of Lanes	1				
Roadway Width (feet)	12				
<b>Roadway Condition Information</b>					
Condition	Good				
Remaining Service Life (years)	7				
Cost Estimate	\$600				
CRV	\$241100

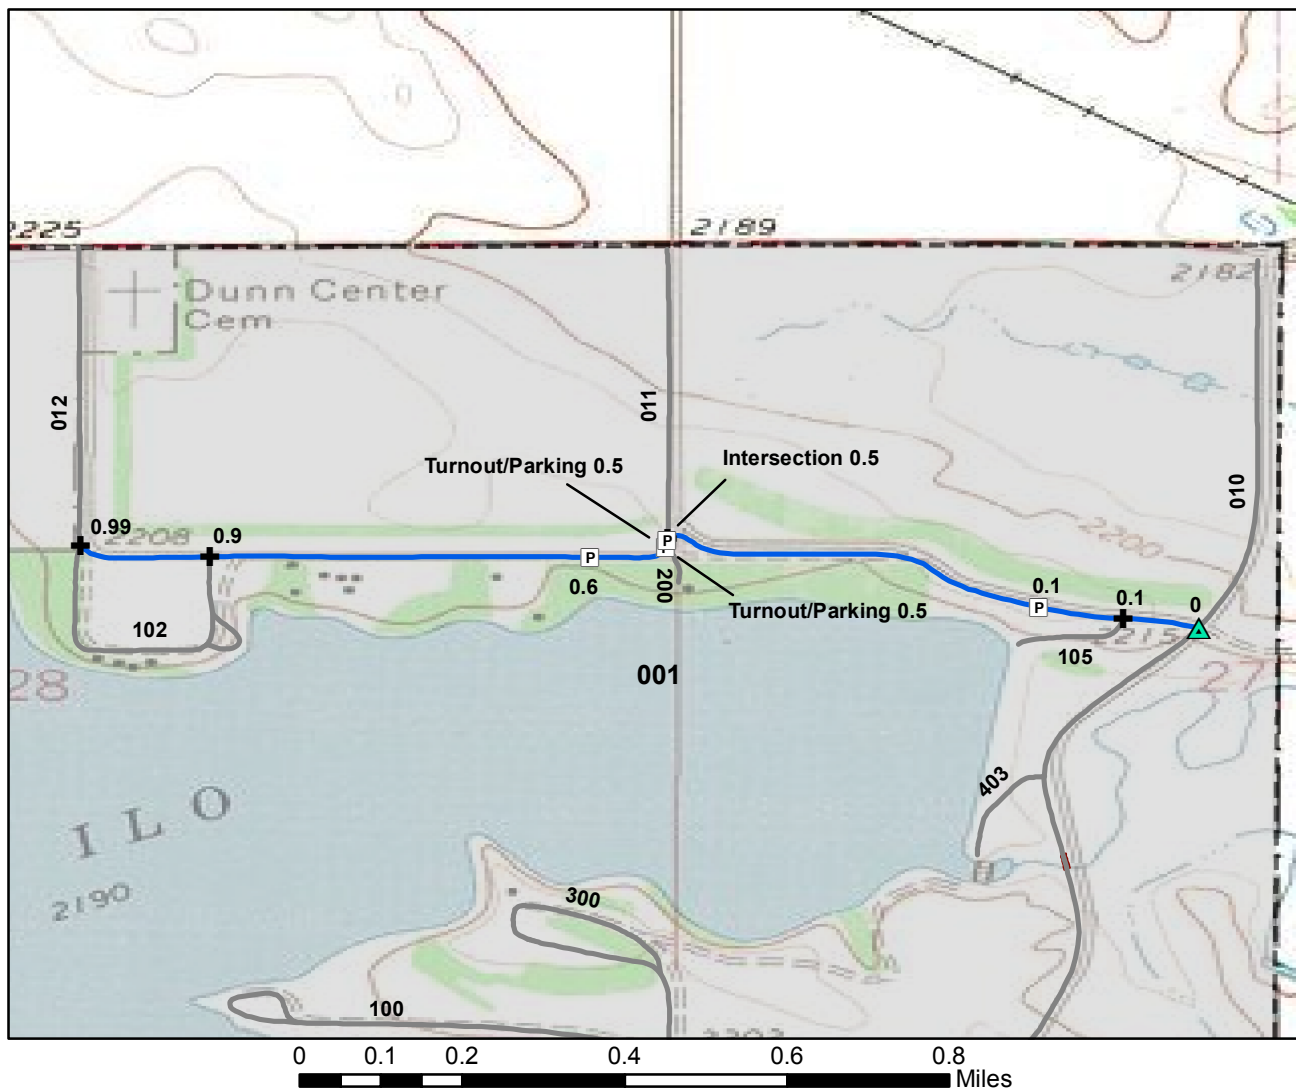
ROUTE: 013 North Shore Drive TOTAL LENGTH: 0.99 Miles

Section Number	001				
Section Length (miles)	0.99				
Inspection Date	7/7/2008				
<b>Section Information</b>					
Surface Type	Gravel				
Number of Lanes	1				
Roadway Width (feet)	12				
<b>Roadway Condition Information</b>					
Condition	Excellent				
Remaining Service Life (years)	8				
Cost Estimate	\$0				
CRV	\$647000

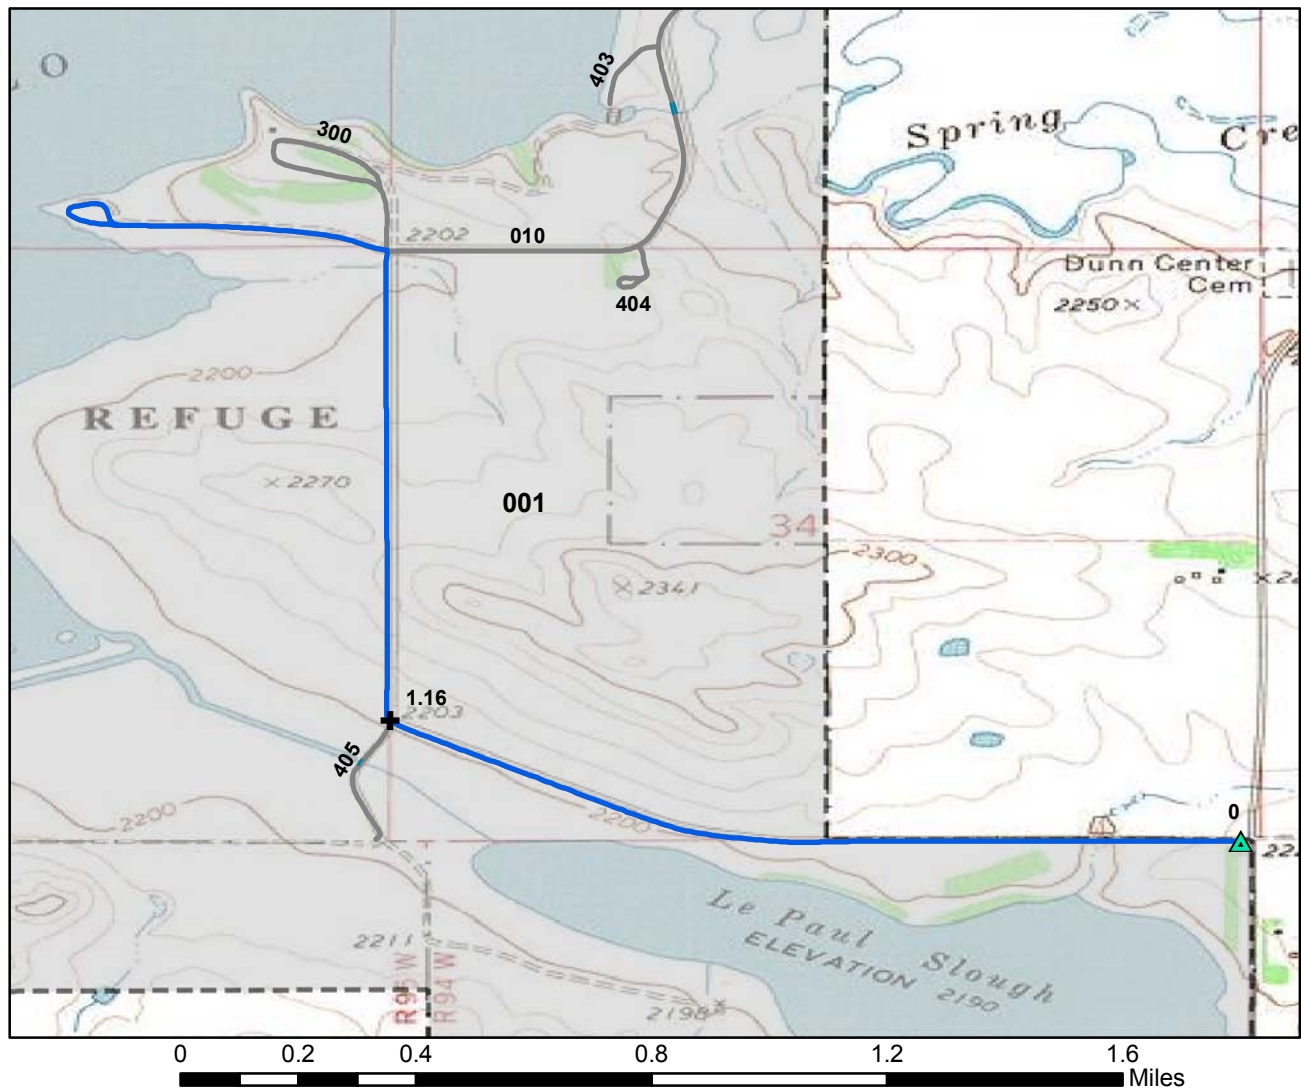
ROUTE: 100 Observation Point Road

Section Number	001				
Section Length (miles)	2.30				
Inspection Date	7/7/2008				
<b>Section Information</b>					
Surface Type	Gravel				
Number of Lanes	1				
Roadway Width (feet)	10				
<b>Roadway Condition Information</b>					
Condition	Excellent				
Remaining Service Life (years)	8				
Cost Estimate	\$0				
CRV	\$1510000

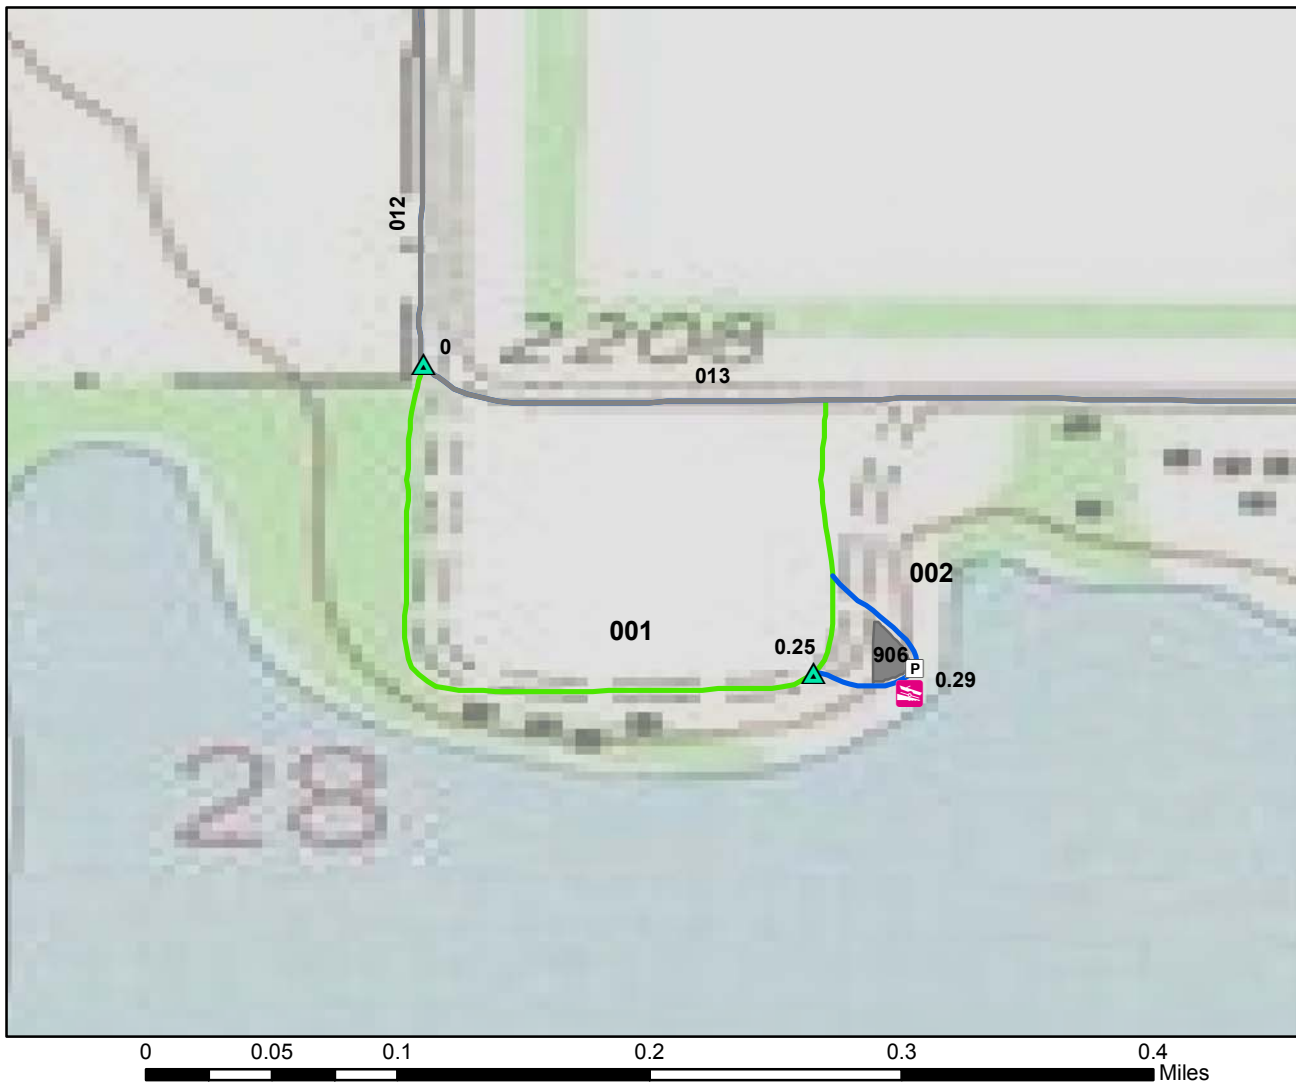
ROUTE: 102      Boat Launch Loop      TOTAL LENGTH: 0.42 Miles

Section Number	001	002			
Section Length (miles)	0.34	0.08			
Inspection Date	7/7/2008	7/7/2008			
<b>Section Information</b>					
Surface Type	Gravel	Gravel			
Number of Lanes	1	1			
Roadway Width (feet)	10	10			
<b>Roadway Condition Information</b>					
Condition	Good	Excellent			
Remaining Service Life (years)	7	10			
Cost Estimate	\$500	\$0			
CRV	\$226500	\$49900

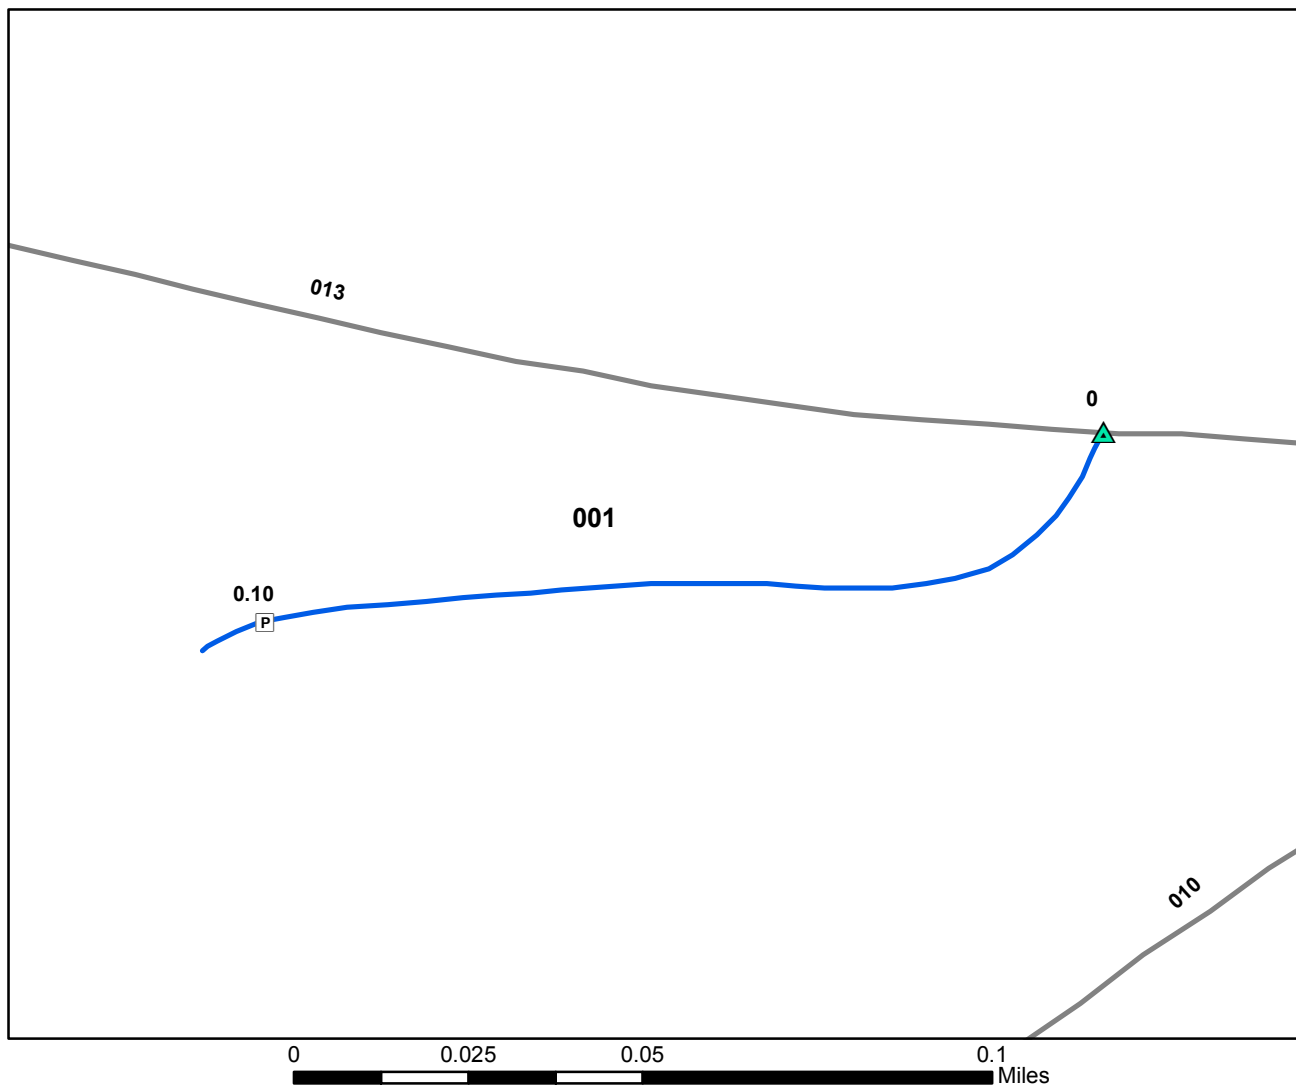
ROUTE: 105 Fishing Pier Access Road TOTAL LENGTH: 0.10 Miles

Section Number	001				
Section Length (miles)	0.10				
Inspection Date	7/7/2008				
<b>Section Information</b>					
Surface Type	Gravel				
Number of Lanes	1				
Roadway Width (feet)	10				
<b>Roadway Condition Information</b>					
Condition	Excellent				
Remaining Service Life (years)	9				
Cost Estimate	\$0				
CRV	\$67000

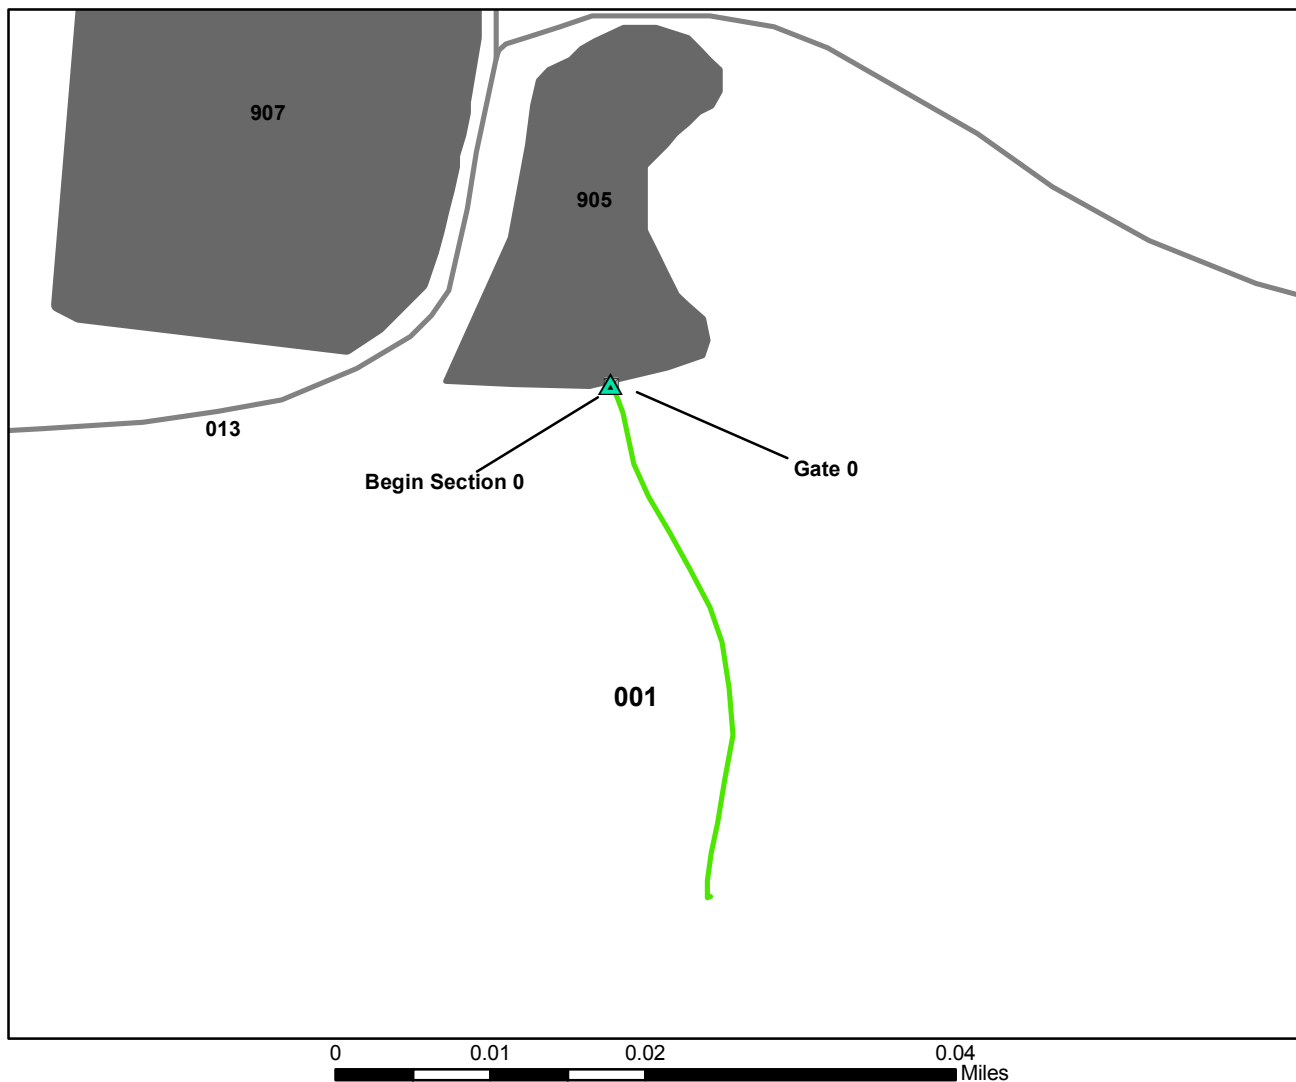
ROUTE: 200 Picnic Area Access Road

Section Number	001				
Section Length (miles)	0.03				
Inspection Date	7/7/2008				
<b>Section Information</b>					
Surface Type	Gravel				
Number of Lanes	1				
Roadway Width (feet)	8				
<b>Roadway Condition Information</b>					
Condition	Good				
Remaining Service Life (years)	7				
Cost Estimate	\$100				
CRV	\$22600

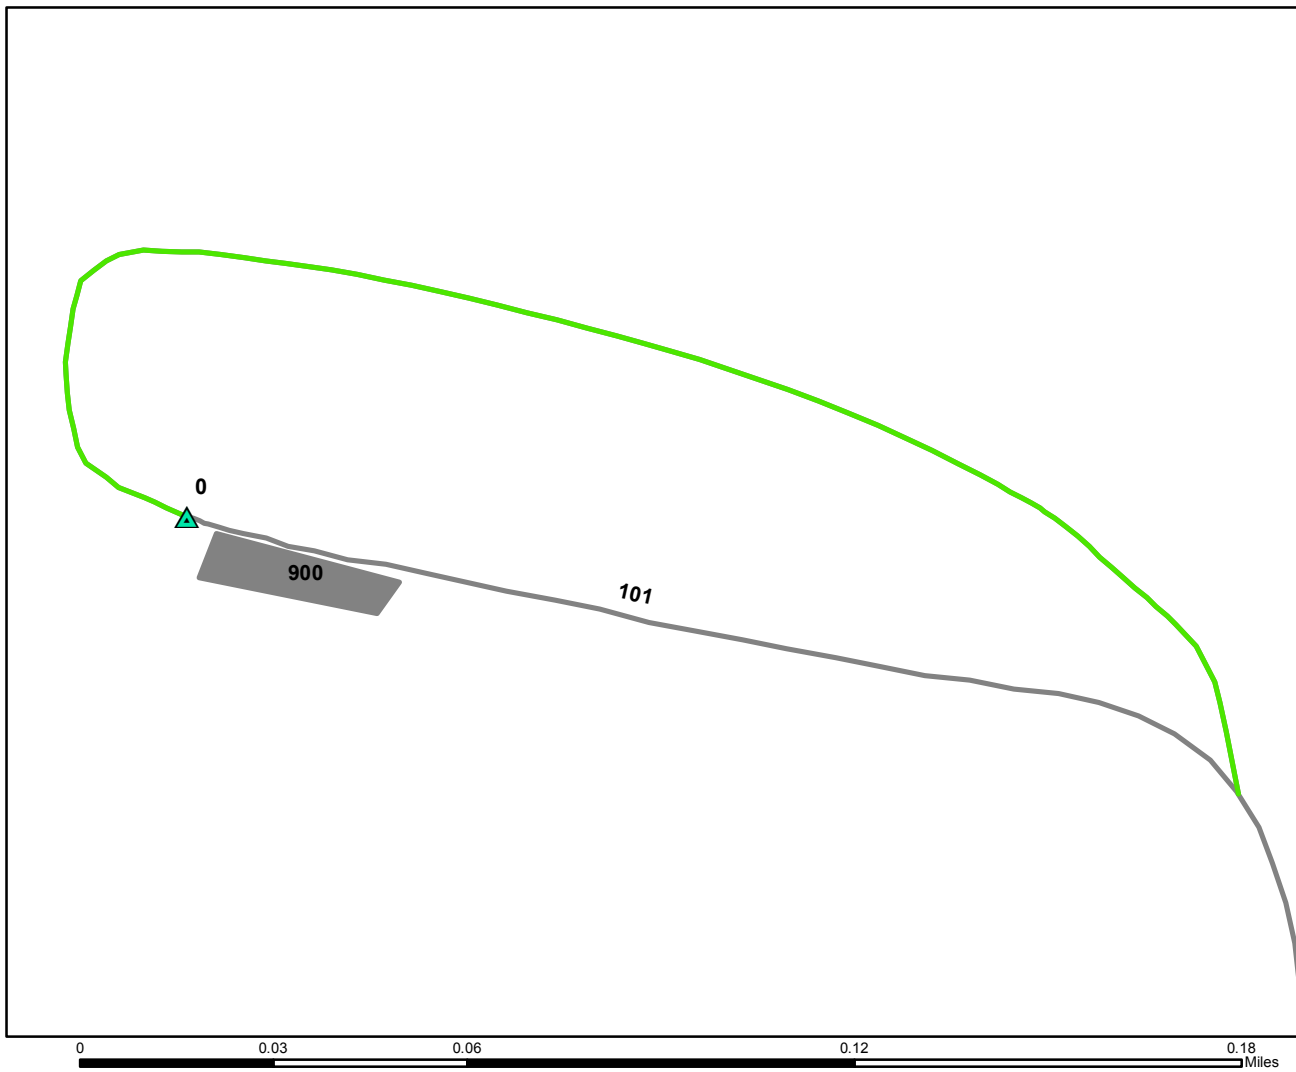
ROUTE: 300 Headquarters Loop Road

Section Number	001				
Section Length (miles)	0.21				
Inspection Date	7/7/2008				
<b>Section Information</b>					
Surface Type	Gravel				
Number of Lanes	1				
Roadway Width (feet)	10				
<b>Roadway Condition Information</b>					
Condition	Good				
Remaining Service Life (years)	7				
Cost Estimate	\$300				
CRV	\$134800

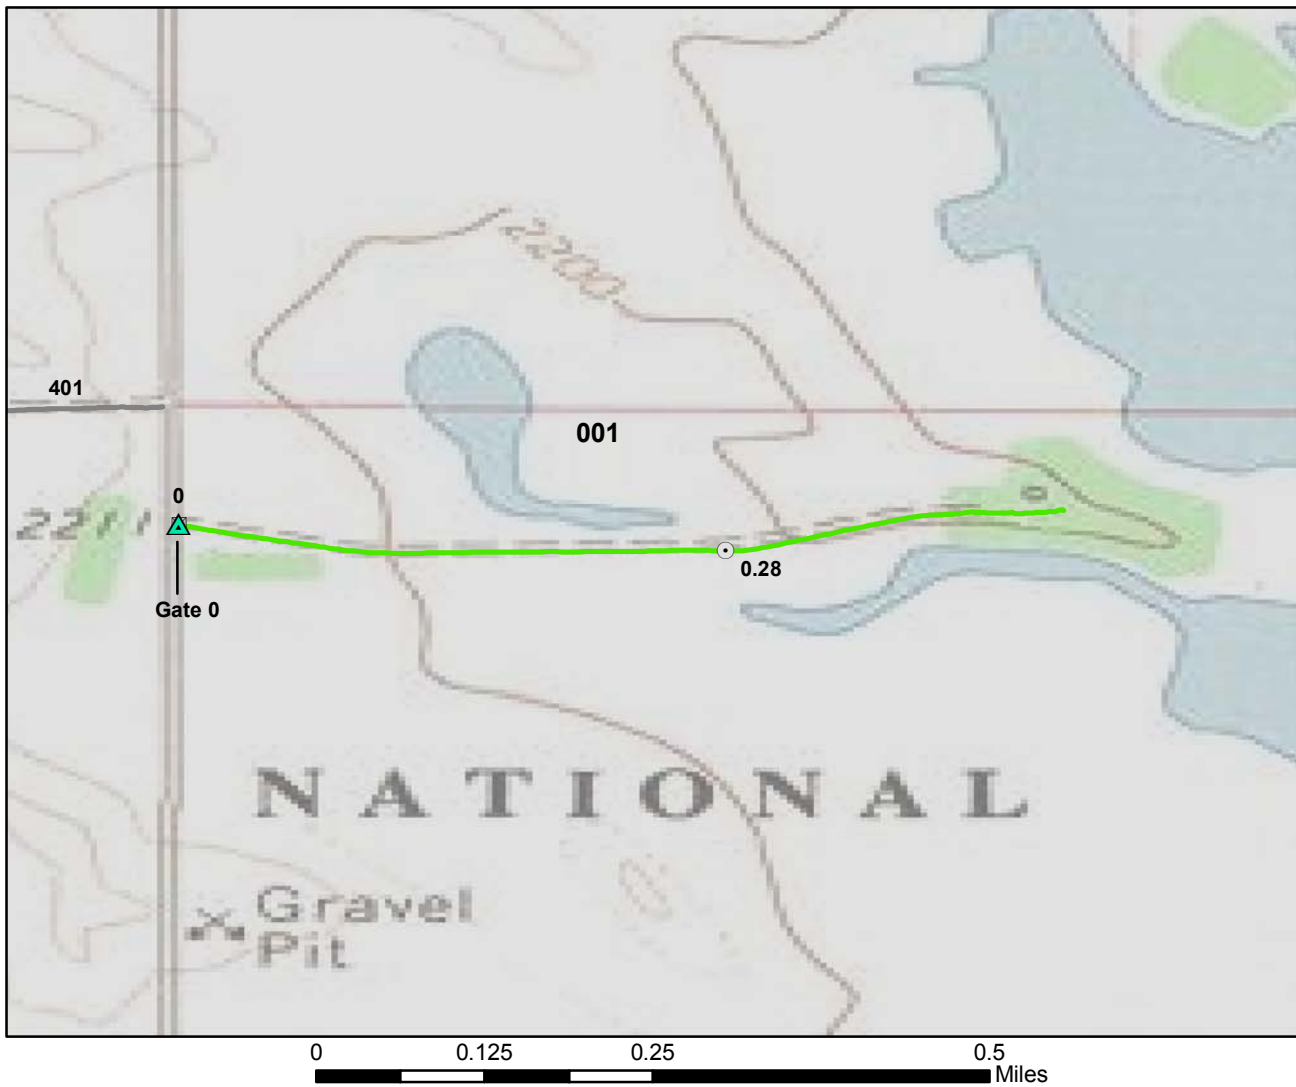
ROUTE: 400 Donohoe Road

Section Number	001				
Section Length (miles)	0.45				
Inspection Date	7/7/2008				
<b>Section Information</b>					
Surface Type	Primitive				
Number of Lanes	1				
Roadway Width (feet)	8				
<b>Roadway Condition Information</b>					
Condition	Good				
Remaining Service Life (years)	7				
Cost Estimate	\$200				
CRV	\$0

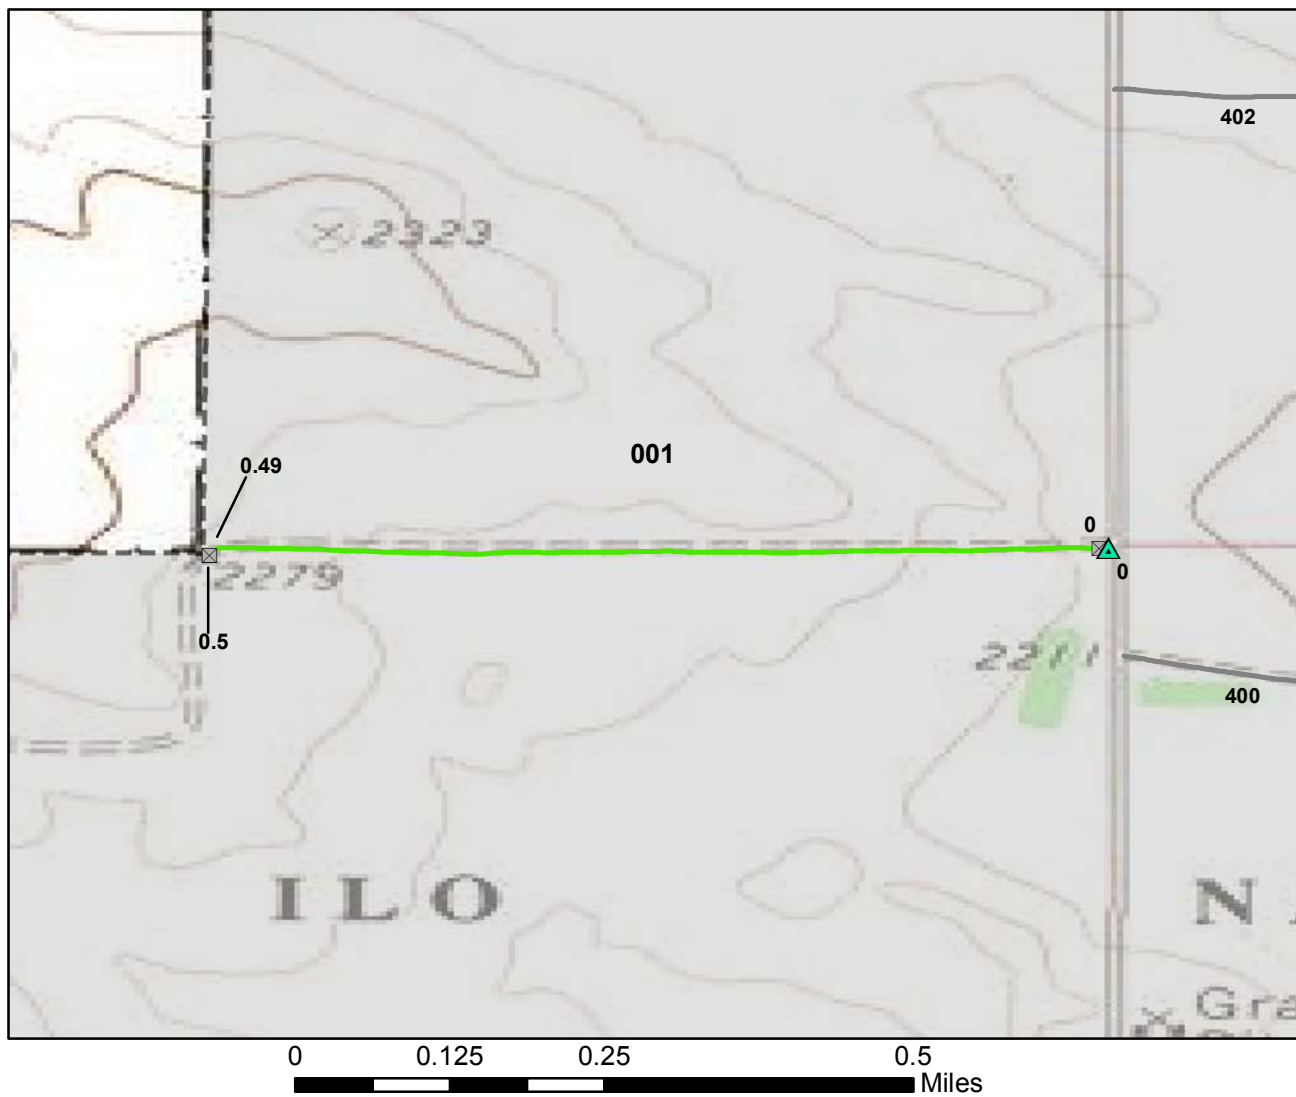
ROUTE: 401 Windmill Road TOTAL LENGTH: 0.50 Miles

Section Number	001				
Section Length (miles)	0.50				
Inspection Date	7/7/2008				
<b>Section Information</b>					
Surface Type	Primitive				
Number of Lanes	1				
Roadway Width (feet)	8				
<b>Roadway Condition Information</b>					
Condition	Good				
Remaining Service Life (years)	5				
Cost Estimate	\$200				
CRV	\$0

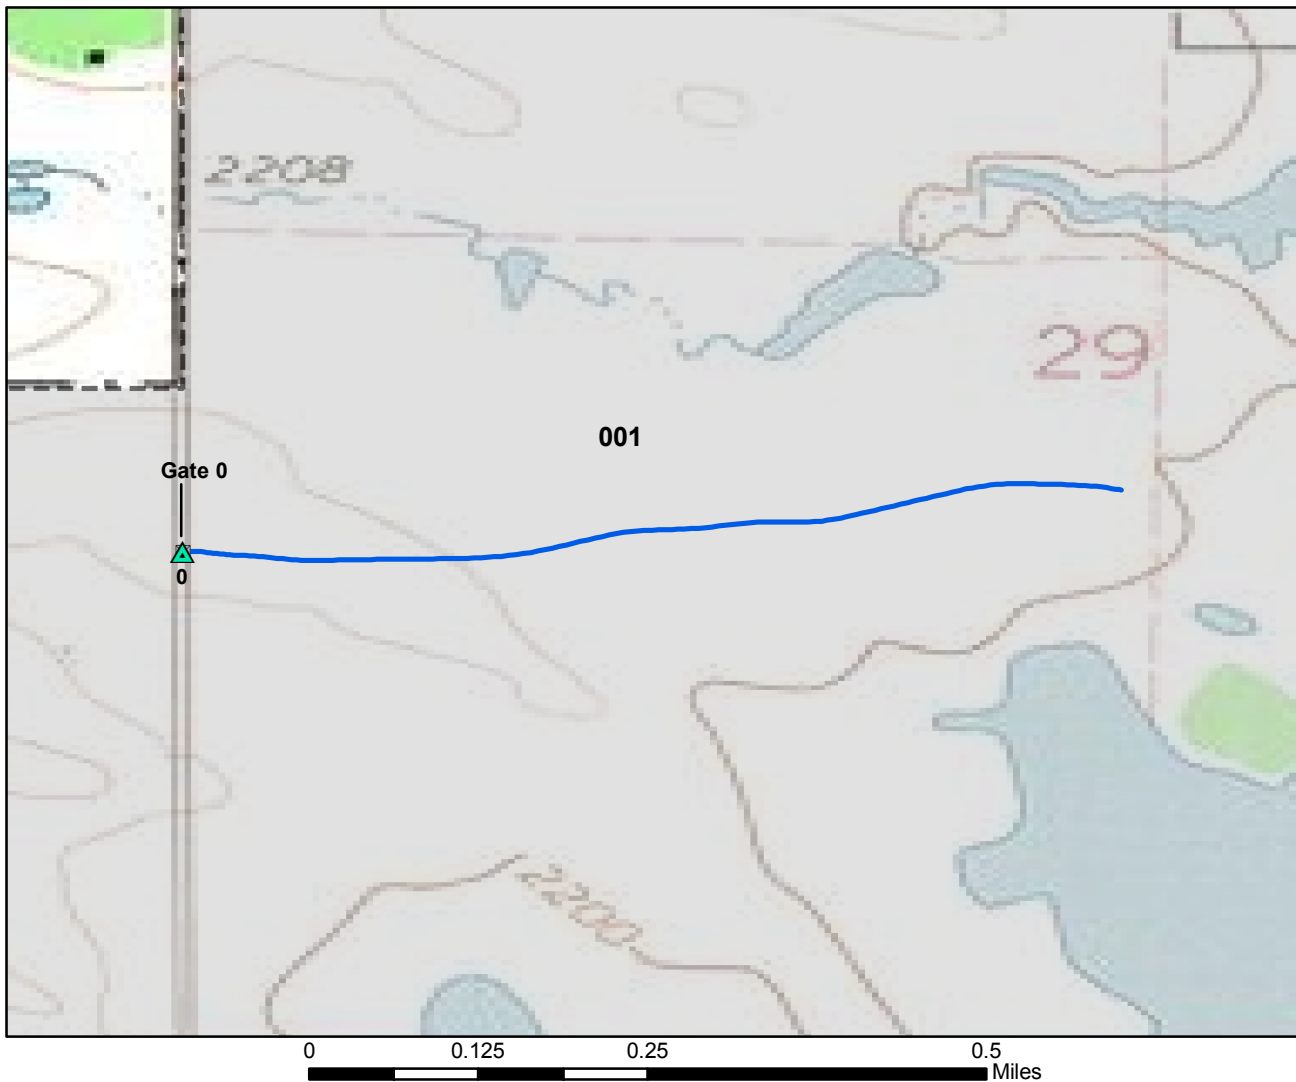
ROUTE: 402 Sharp-tail Road

Section Number	001				
Section Length (miles)	0.48				
Inspection Date	7/7/2008				
<b>Section Information</b>					
Surface Type	Primitive				
Number of Lanes	1				
Roadway Width (feet)	8				
<b>Roadway Condition Information</b>					
Condition	Excellent				
Remaining Service Life (years)	9				
Cost Estimate	\$0				
CRV	\$0

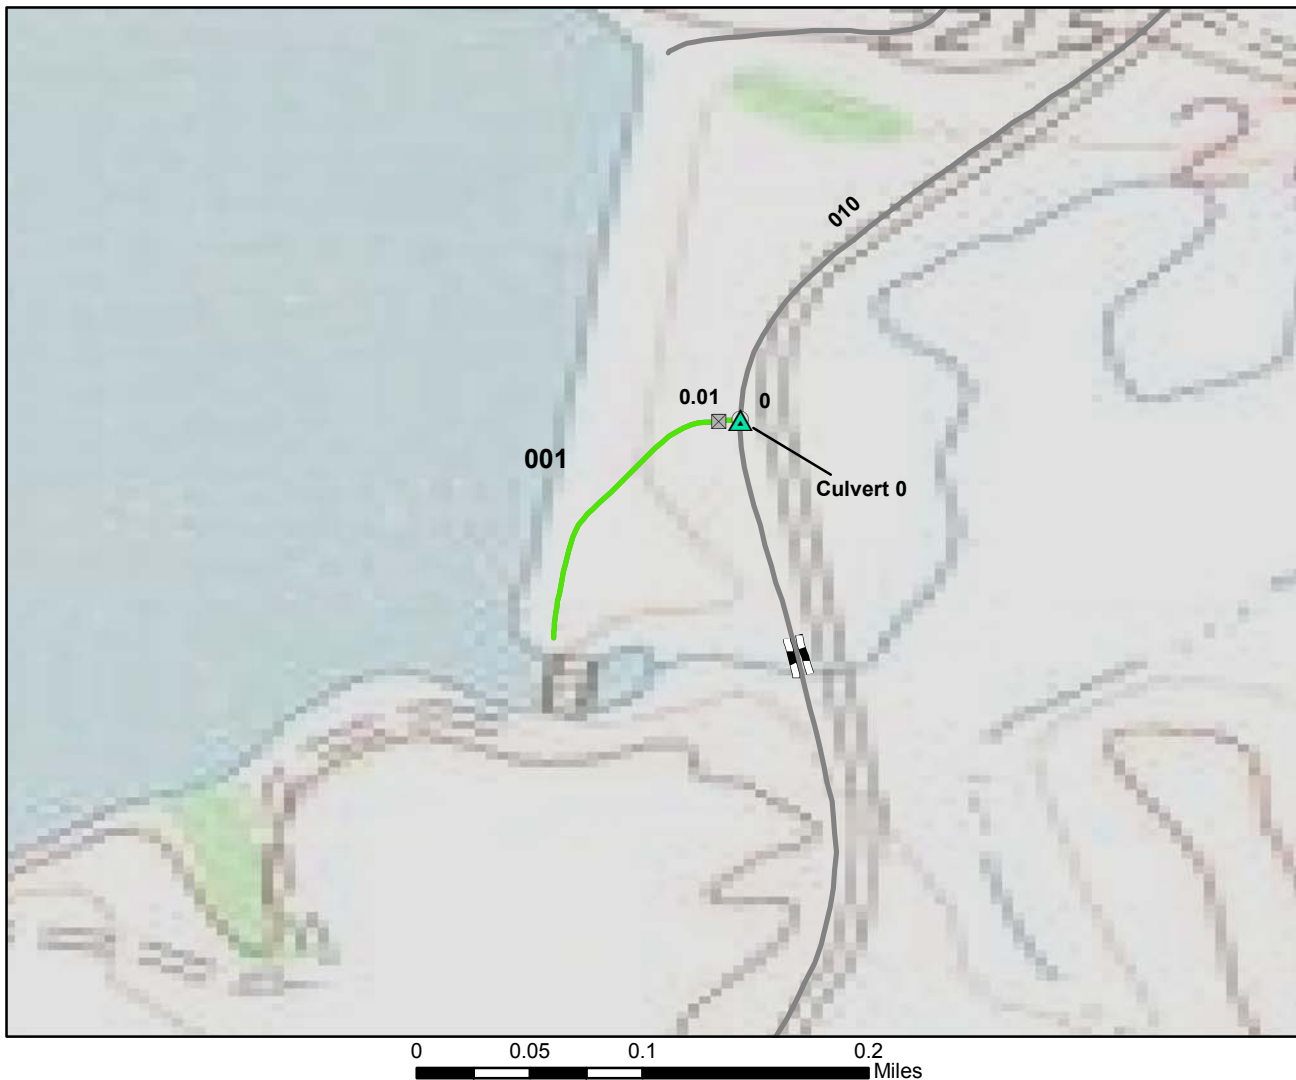
ROUTE: 403 Dam Access Road

Section Number	001				
Section Length (miles)	0.12				
Inspection Date	7/7/2008				
<b>Section Information</b>					
Surface Type	Gravel				
Number of Lanes	1				
Roadway Width (feet)	8				
<b>Roadway Condition Information</b>					
Condition	Good				
Remaining Service Life (years)	7				
Cost Estimate	\$200				
CRV	\$80200

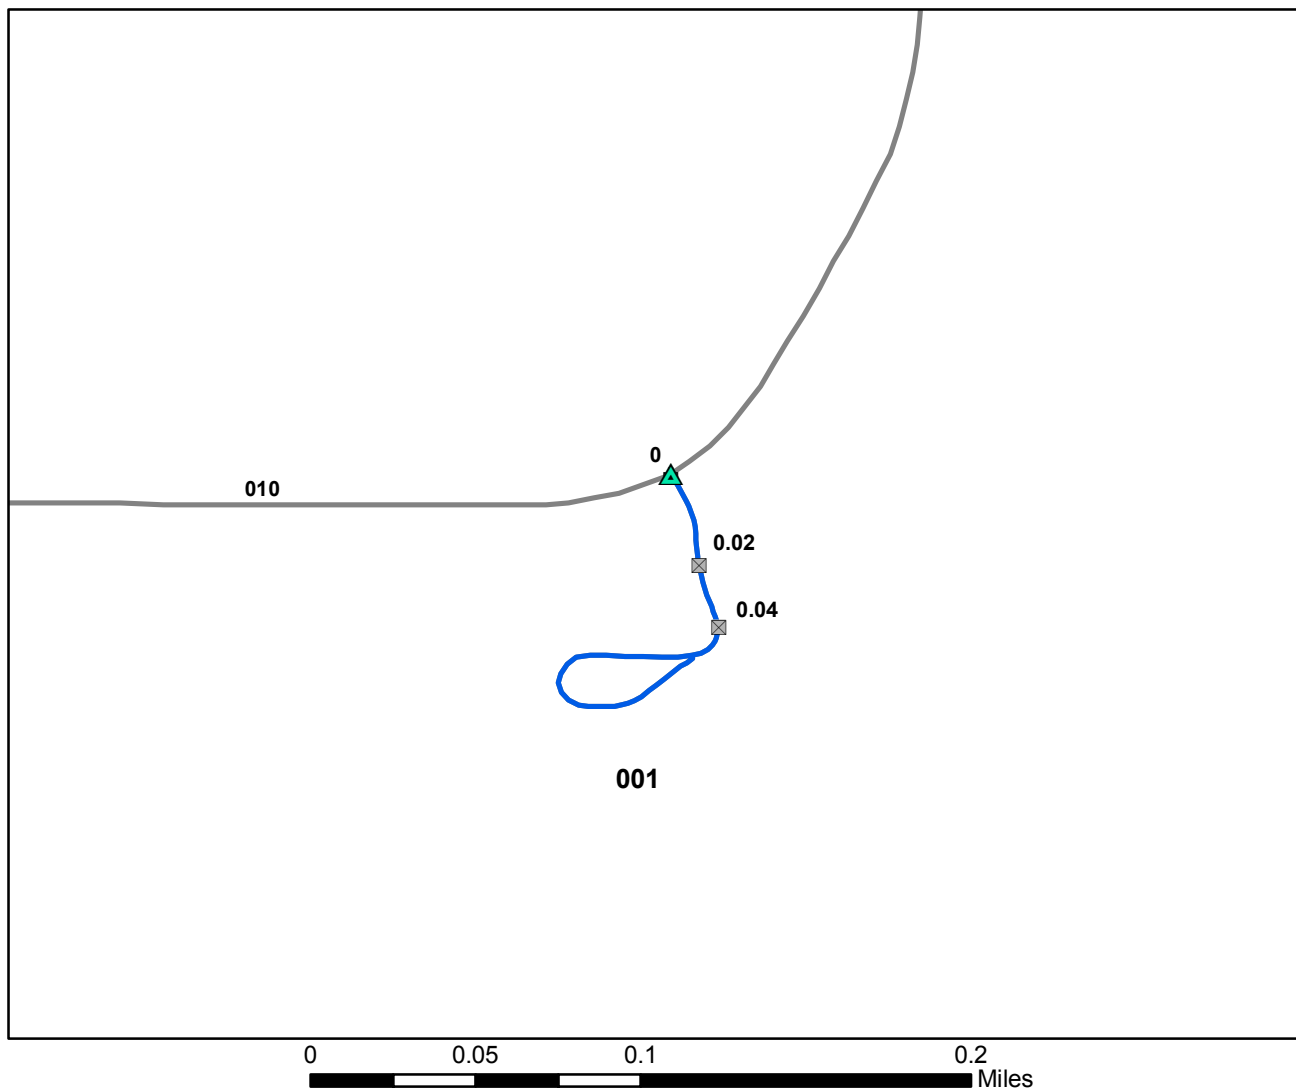
ROUTE: 404 Bone Yard Road

Section Number	001				
Section Length (miles)	0.13				
Inspection Date	7/7/2008				
<b>Section Information</b>					
Surface Type	Gravel				
Number of Lanes	1				
Roadway Width (feet)	10				
<b>Roadway Condition Information</b>					
Condition	Excellent				
Remaining Service Life (years)	9				
Cost Estimate	\$0				
CRV	\$85000

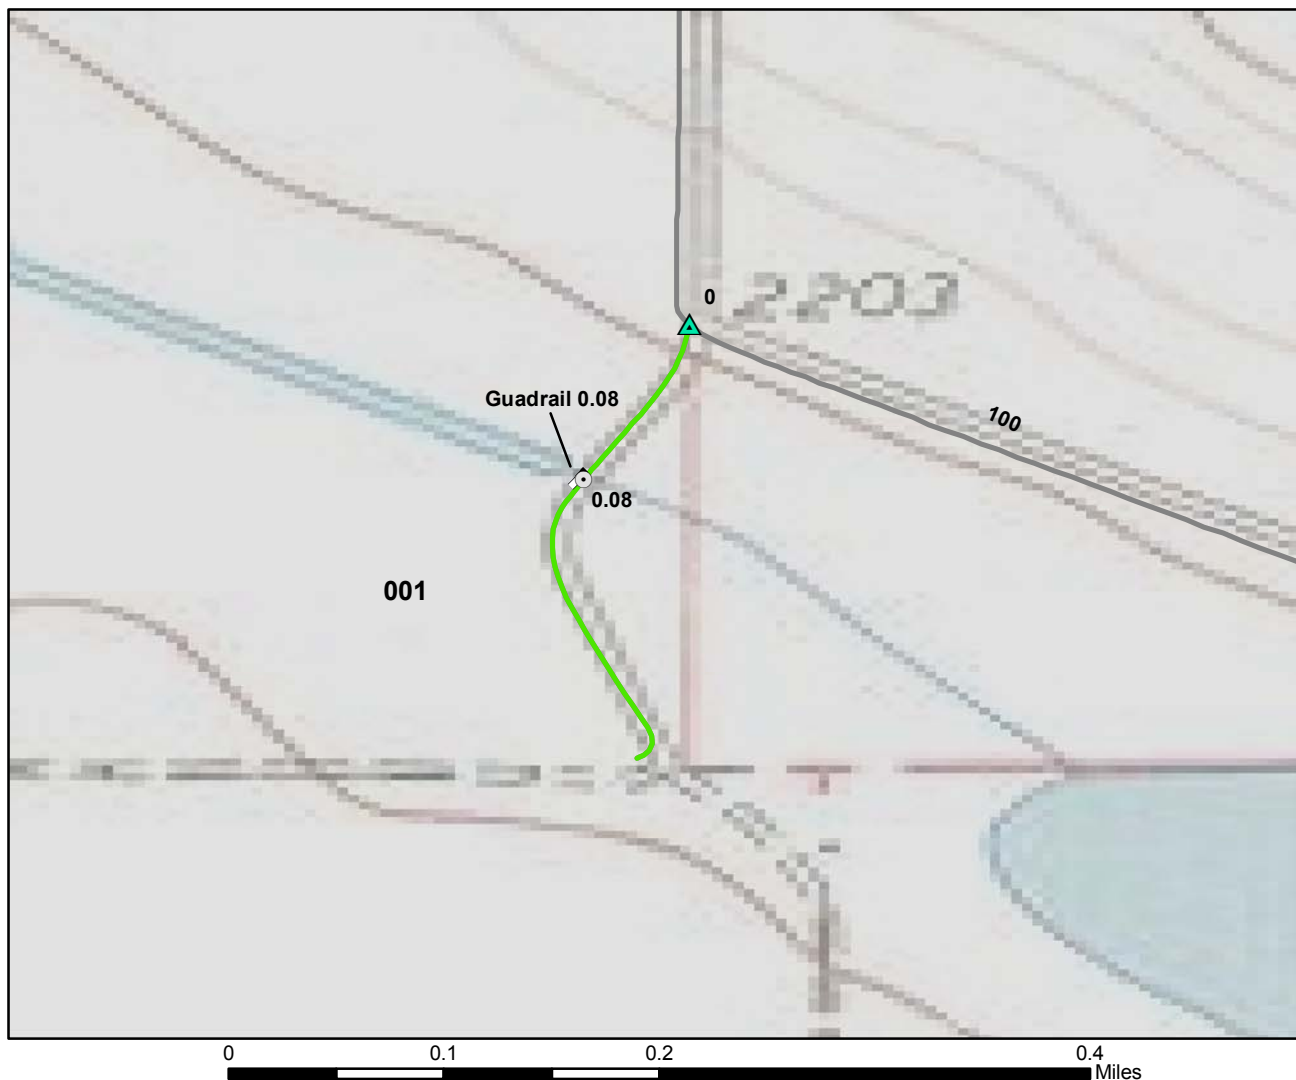
ROUTE: 405 Lee Paul Structure Road

Section Number	001				
Section Length (miles)	0.22				
Inspection Date	7/7/2008				
<b>Section Information</b>					
Surface Type	Native				
Number of Lanes	1				
Roadway Width (feet)	10				
<b>Roadway Condition Information</b>					
Condition	Good				
Remaining Service Life (years)	7				
Cost Estimate	\$400				
CRV	\$74700

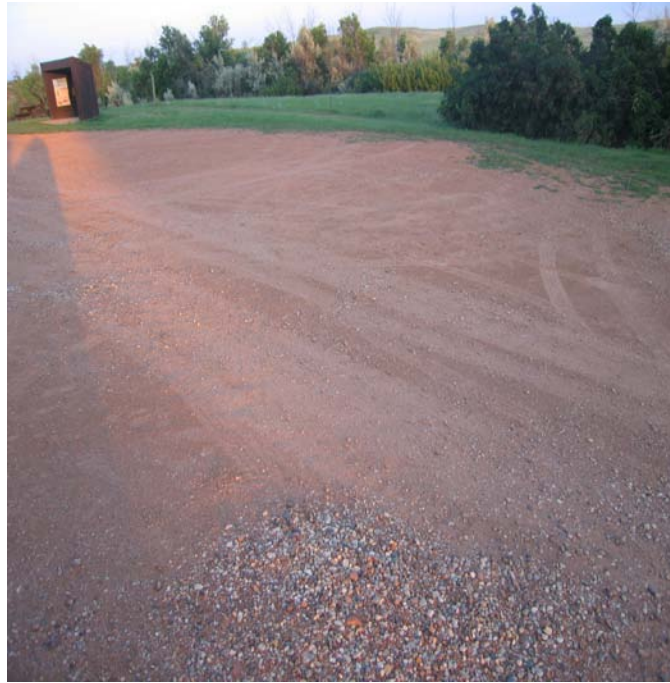
## Route 900: Headquarters Parking

Asset Number	Date Visited	Surface Type	Area (sq ft)	Condition	Cost to Improve
10028437	7/7/2008	Gravel	3541	Good	\$500
